INVESTIGATION OF CONSTRUCTION MATERIAL QUALITY AND WORKMANSHIP DEFECTS OF RC BUILDINGS COLLAPSED AND SEVERELY DAMAGED IN THE 6.8 MW SIVRICE, ELAZIĞ, TURKEY, EARTHQUAKE, JANUARY 2020

ABSTRACT

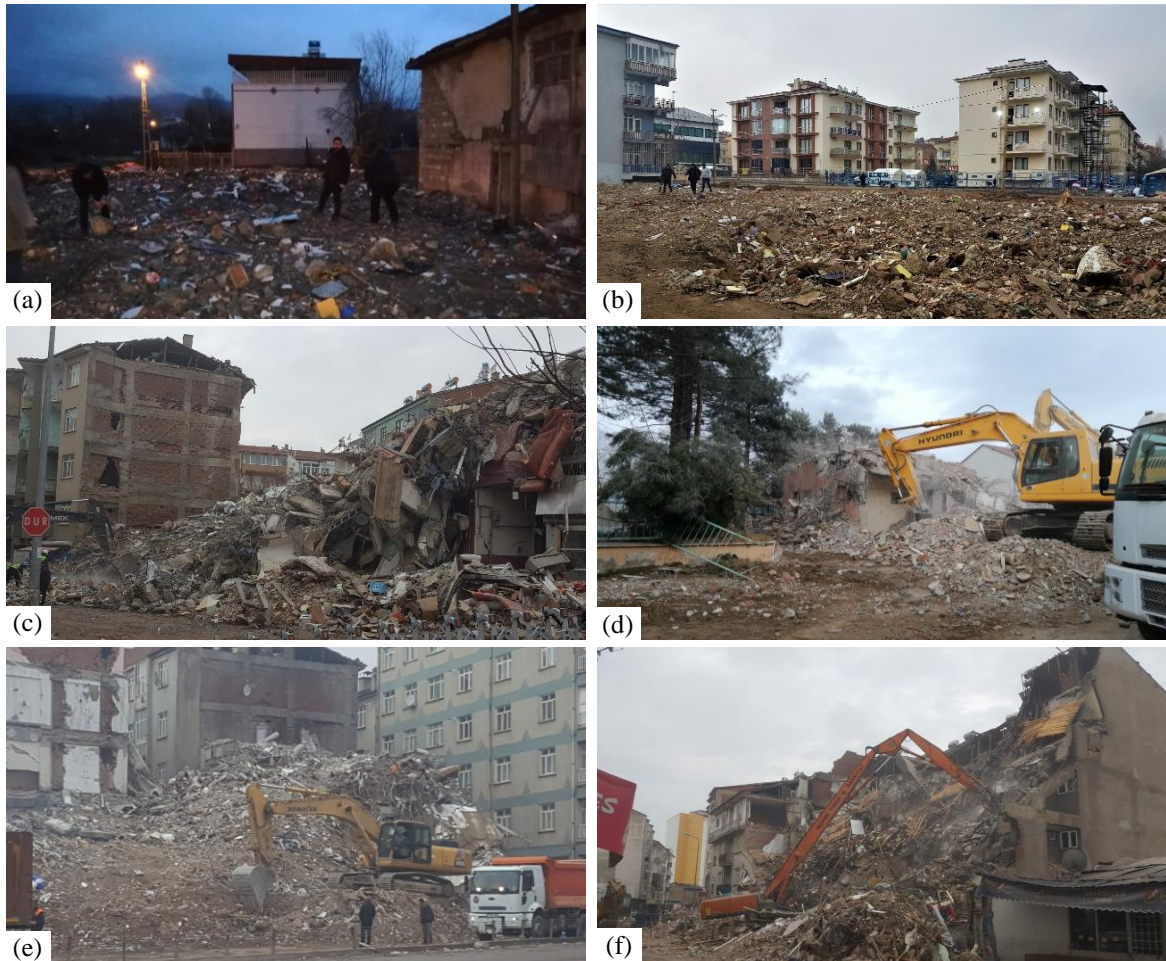
Figure 3: Some of the collapsed and severely damaged buildings from which the material samples were taken in Elazığ; (a) C01, (b) C02, (c) C04, (d) D05, (e) D12, (f) D18.

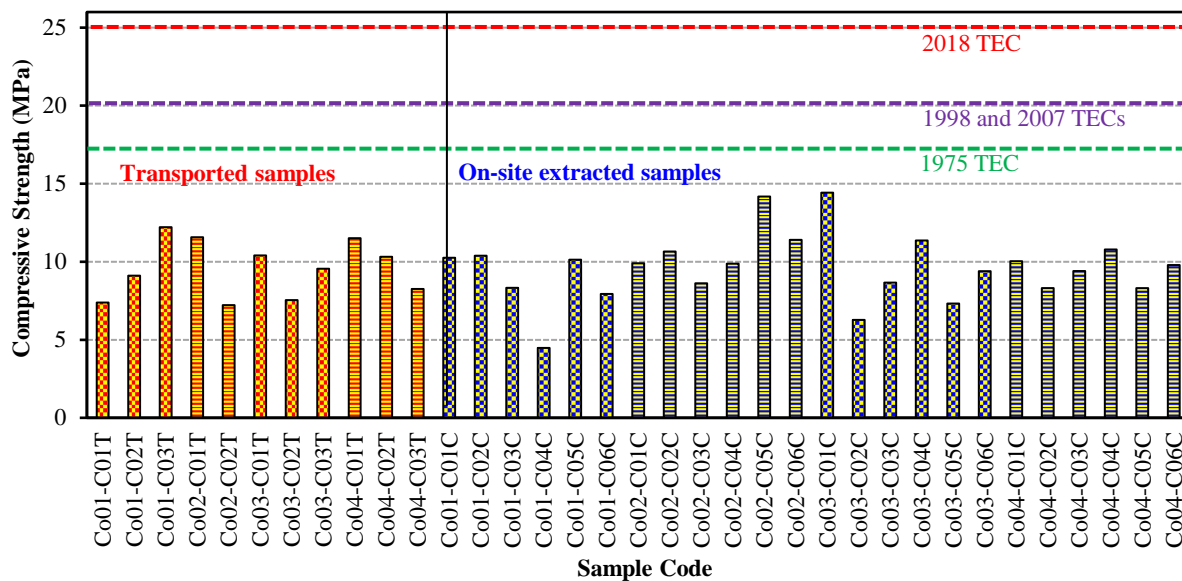
As shown in Figure 7, the highest concrete compressive strength value for the collapsed buildings was 14.43 MPa, while the lowest was 4.48 MPa. Overall the mean concrete strength was calculated as 9.58 MPa (extremely low). Since the oldest one among the four collapsed buildings was constructed in 1987, TEC 1975 and the following TECs are used here for comparison and discussion. According to the Turkey Earthquake Zones Map [53], the Sivrice district near the epicentre is located in a 1st-degree seismic zone. However, the city centre of Elazığ is situated in a 2nd-degree seismic zone [53]. Therefore, the minimum concrete strength requirement for 1975 TEC in Figure 7 is shown for these seismic zones.

Figure 7: Compressive strengths of the concrete core samples of collapsed buildings.

2018 TEC [31]. The minimum compressive strength requirement is also marked in all charts (Figures 7-9,15). According to Figure 7, it is obvious that the collapsed buildings had lower concrete strength values compared to the minimum value stated in the relevant earthquake codes.

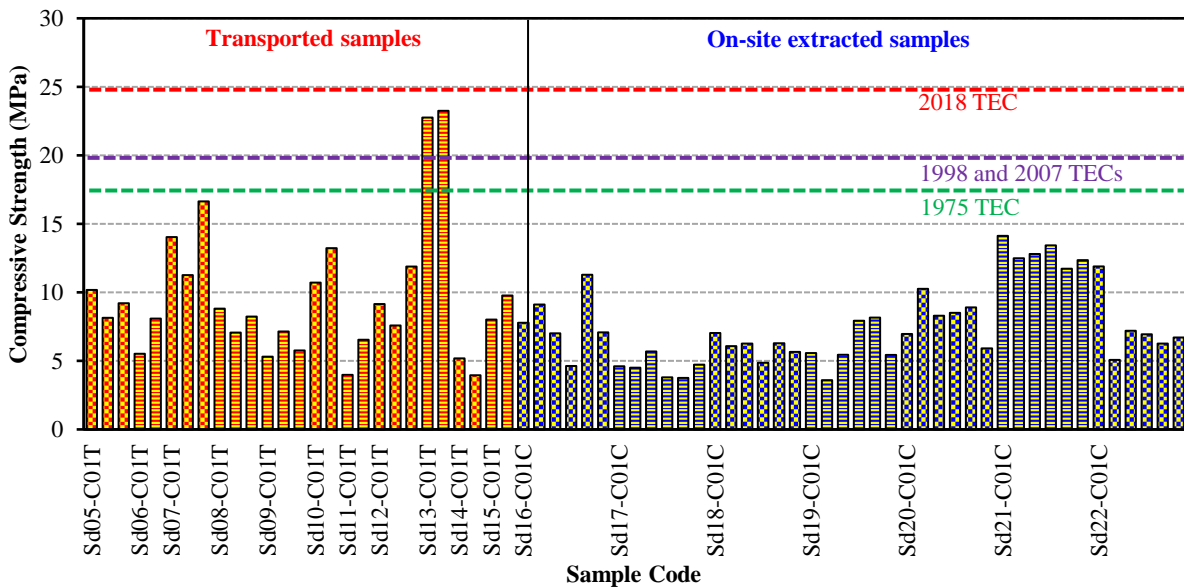
The correction factor recommended in ASTM C42 [52] was also applied to these samples. The compressive strength values in comparison to the relevant standards [50,51] are provided in Figure 8. Since the sample codes in horizontal axis labels do not fit on the axis in Figure 8, only the first sample code of each building is written. Unlabelled codes that follow the labelled samples belong to the other samples belonging to the same building. The severely damaged oldest building examined in this study was built in 1989. For this reason, the concrete class requirement according to 1975 TEC is also marked in Figure 8. The concrete compressive strength values of the core samples that belong to the severely damaged buildings are as follows: 23.25 MPa the highest, 3.60 MPa the lowest and 8.37 MPa the mean.

Figure 8: Compressive strengths of the concrete core samples of severely damaged buildings.

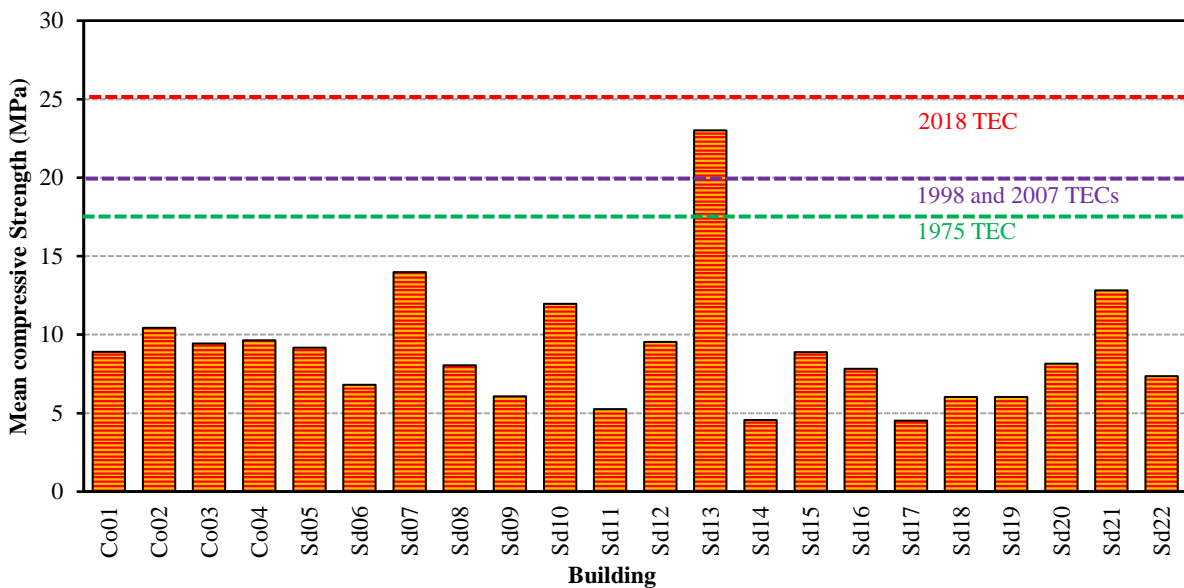
transport and conventional onsite methods. It is clear from Figure 9 that the buildings' compressive strength values, except one, do not match the minimum strength requirements. When their compressive strength is considered, it is understood that these buildings were designed without engineering service or built without inspection.

Figure 9: Mean compressive strengths of the concrete core samples of collapsed/severely damaged buildings.

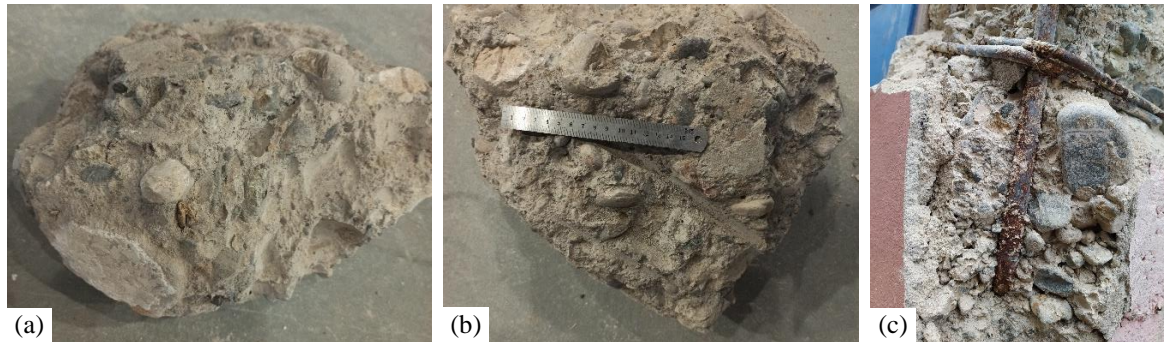
aggregate in coastal regions, etc. Similar problems regarding concrete quality were also encountered in the collapsed buildings in Elazığ (Figure 10).

Figure 10: Rounded and poorly gradated aggregates and organic materials in concrete, (a, b) transported concrete pieces, (c) concrete of a column observed on site.

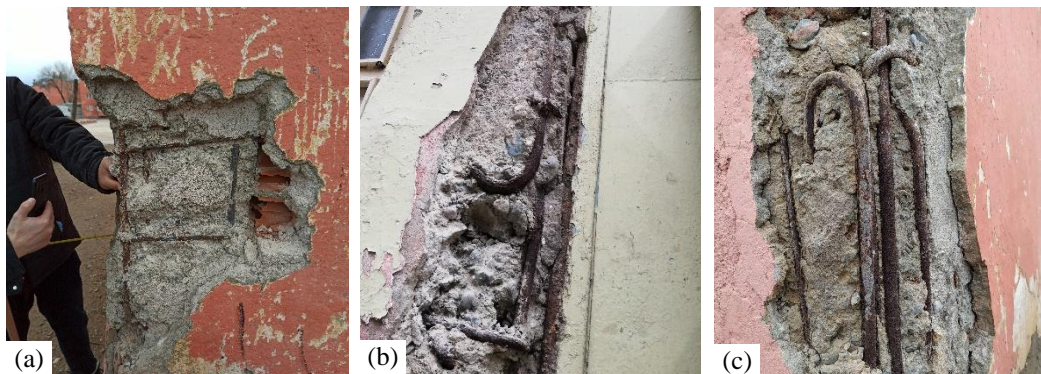
An RC member can only resist loads if concrete and steel reinforcement work as a whole with a proper bond in between. Corrosion is a significant problem affecting the adherence between the two materials. One of the most important causes of reinforcement corrosion is salts in the surrounding concrete. Various salt solutions in seawater cause salt content in sand and aggregates taken from the sea. Due to the widespread use of rounded sea aggregate in concrete, corroded reinforcement was also encountered in most Marmara earthquake buildings [30]. Especially in places with high humidity, reinforcement corrosion increases because of insufficient concrete compaction and cover concrete. Similar corrosion problems were also observed in the damaged buildings in the Elazığ earthquake (Figure 11).

Figure 11: High level of reinforcement corrosion in the buildings in Elazığ, (a) corroded longitudinal and transverse reinforcements, (b, c) visible rust layer on the concrete-rebar contact surface.

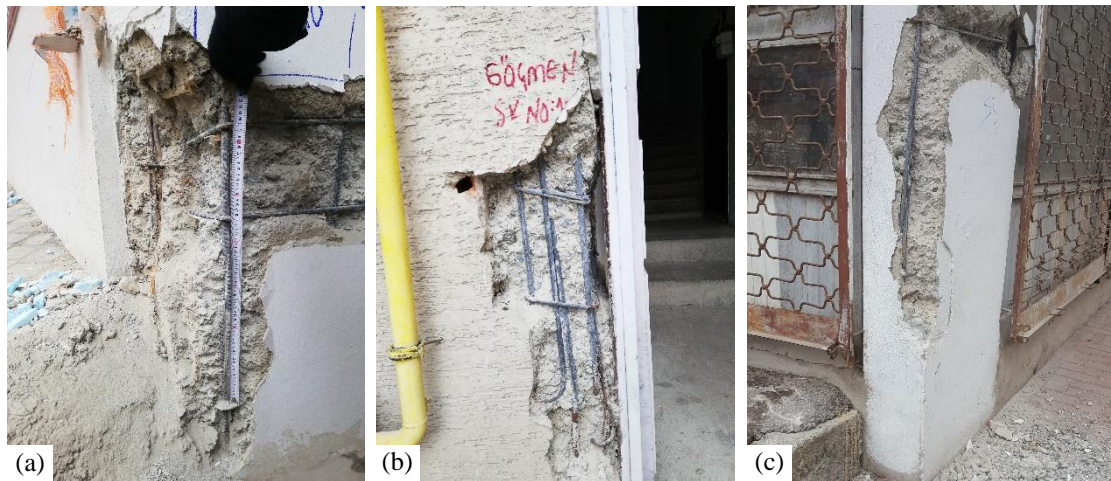
During the earthquakes, the force transmission did not occur properly due to the lack of adequate development length in longitudinal bars and widely spaced transverse reinforcements in lap splices. In the Elazığ earthquake, many severely damaged buildings with insufficient stirrup spacing and development length in lap splices were encountered. (Figure 12).

Figure 12: Lap splice defects in damaged buildings in Elazığ; (a) excessive distance between stirrups/stirrup legs, (b) inadequate development length and confinement defects: large spacing and hook angle, (c) 75 cm stirrup spacing at a lap splice.

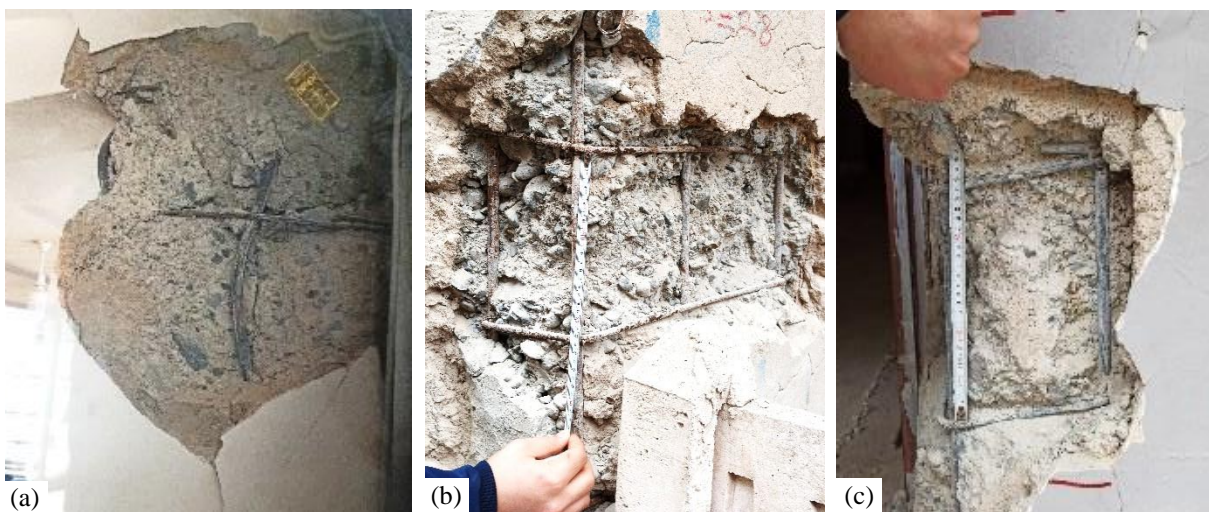
Transverse reinforcement details have vital importance in seismic performance of reinforced concrete buildings. For example, reinforced concrete members can suffer shear damage due to inappropriate stirrup spacing and insufficient hook length and angle. Before columns reach their bending capacity, stirrup hooks with insufficient length/angle open and cause columns to lose their confinement, which causes shear damage and instability. Especially, insufficient confinement reinforcement in columns and/or stirrups with 90° hooks that do not effectively work as confinement have been identified as common problems in the buildings damaged in almost all recent earthquakes in Turkey [28, 30, 59, 60]. However, according to the 1975 TEC, 1997 TEC, and 2007 TEC, lateral reinforcement spacing shall not be more than 10 cm; stirrups shall always have 135° hooks at both ends, leaving at least 8 cm linear length for S420 and a 10 cm linear length for S220 stirrups. Despite this, insufficient stirrup spacing and hook length, and angle errors were observed in most buildings in Elazığ (Figure 13).

Figure 13: Transverse reinforcement defects in structural members, (a, b, c) Large stirrup spacing, transverse distance between legs and 90° hook angle in the severely damaged buildings in Elazığ.

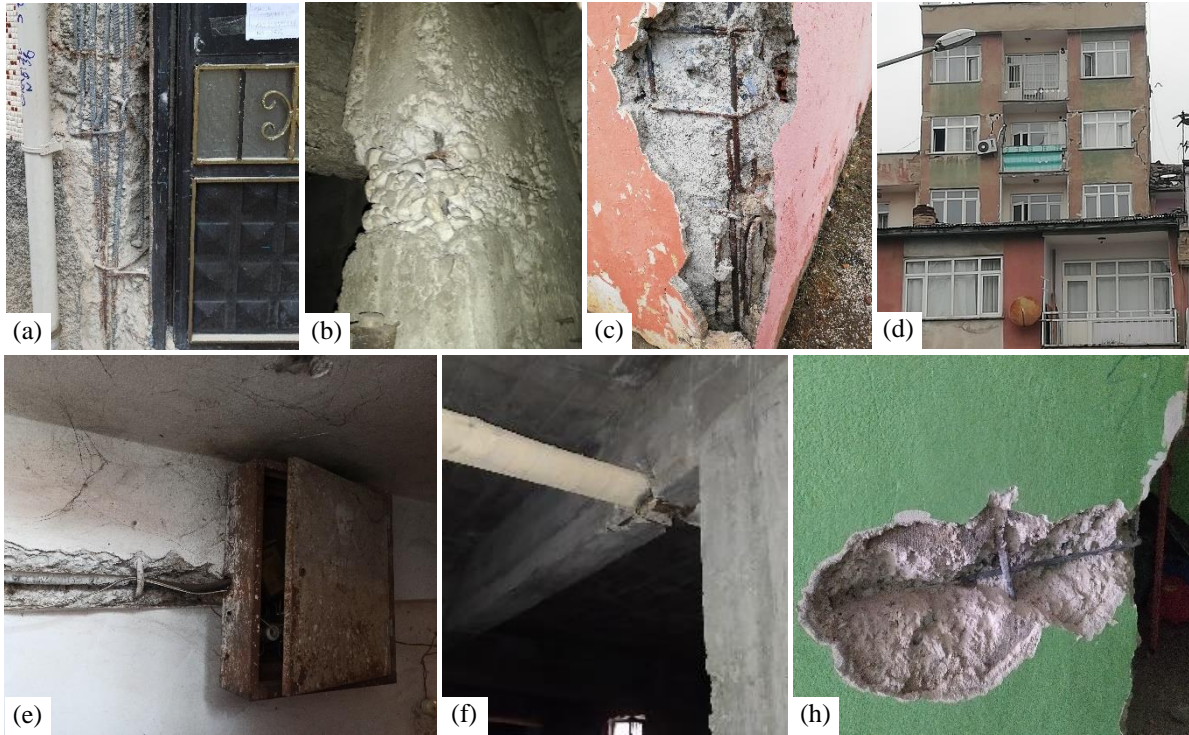
However, some design/workmanship defects and improper practices have been observed in field observations. For example, mounting of the building door by welding to column reinforcement (Figure 14a), poor placement of concrete at basement floor column (Figure 14b), not maintaining the column stirrups within the foundation (Figure 14c), lack of sufficient gap between adjacent buildings resulting in hammering/pounding (Figure 14d), installation of electrical cables and water pipes by damaging the structural elements (Figure 14e,f), placing longitudinal reinforcement outside the stirrup (Figure 14g) were encountered during the investigation.

Figure 14: Observed defect examples such as (a) disturbing the column reinforcement due to the door mounting, (b) poor concrete placing, (c) lack of stirrup at the column longitudinal bar extension in the foundation, (d) damage due to the pounding effect, (e) damaging the beam to install electrical cable, (f) damaging the beam to install water pipe, (g) placing the longitudinal rebar out of the stirrup.

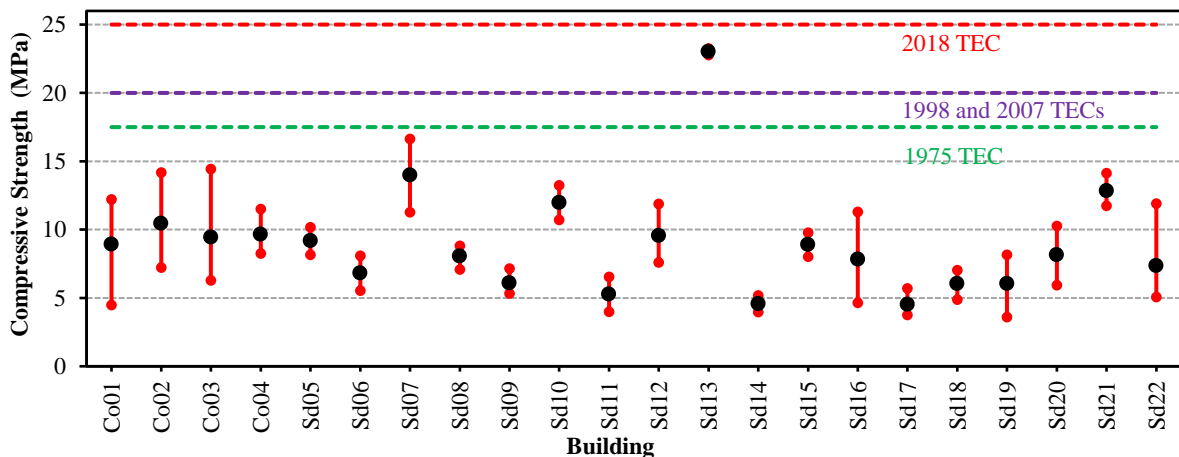
15. The maximum, mean, and minimum compressive strength values are shown with the TEC limits (Figure 15). In Table 3, the buildings whose at least one reinforcement sample does not meet at least one criteria regarding yield, tensile, elongation, and ultimate tensile strength/yield strength ratio according to the TS EN 708 standard are marked as "X".

Figure 15: Max, mean and minimum compressive strengths of the concrete samples of collapsed/severely damaged buildings.
