INVESTIGATION OF CONSTRUCTION MATERIAL QUALITY AND WORKMANSHIP DEFECTS OF RC BUILDINGS COLLAPSED AND SEVERELY DAMAGED IN THE 6.8 MW SIVRICE, ELAZIĞ, TURKEY, EARTHQUAKE, JANUARY 2020

ABSTRACT

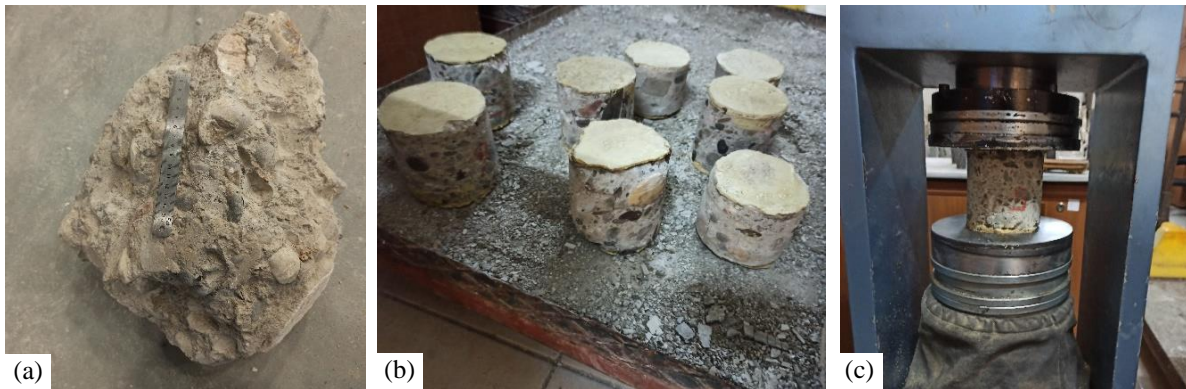
Figure 5: (a) A large piece of concrete and (b) core samples, (c) concrete compression test.

Naturally, it was probable that the concrete cores might have some invisible micro-cracks, which may have affected their compressive strength. However, the authors still preferred the transport method due to the earthquake site's difficulties, as stated before. In addition to the decrease in the strength on account of the micro cracks, there is also an increase in the material strength depending on the time. Thus, in this study, the compressive strengths are presented as obtained from the tests, without adjusting for the factors that may affect the strength.

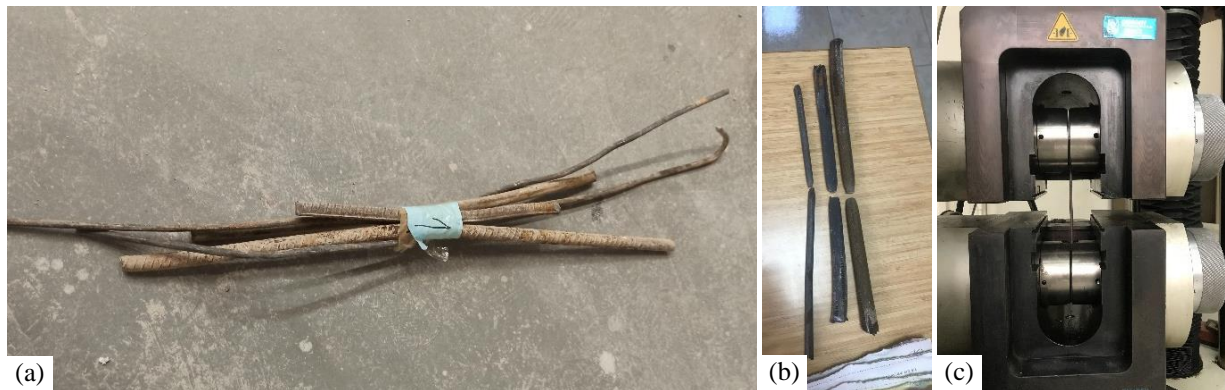
Figure 6: (a) Reinforcement taken from a collapsed buildings' column, (b) tested reinforcement, (c) tension test of a rebar.

Having a sufficient number of reinforcement pieces in adequate lengths, samples meeting the nominal diameter standard were selected. Reinforcement samples in various diameters taken from the collapsed buildings were tested to determine if they were in line with the relevant standard [54] and regulations [32–34] (Figure 6). As a result of the tests, the ratio of elongation at rupture, ultimate tensile strength, yield strength, and ultimate tensile strength/yield strength ratio values, along with the examination of these values, are listed in Table 1.
